UNIVERSITY OF COLORADO 1135 BROADWAY

RENOVATION

BOULDER, COLORADO | 4.10.2020 | DESIGN REVIEW BOARD | SCHEMATIC DESIGN REVIEW

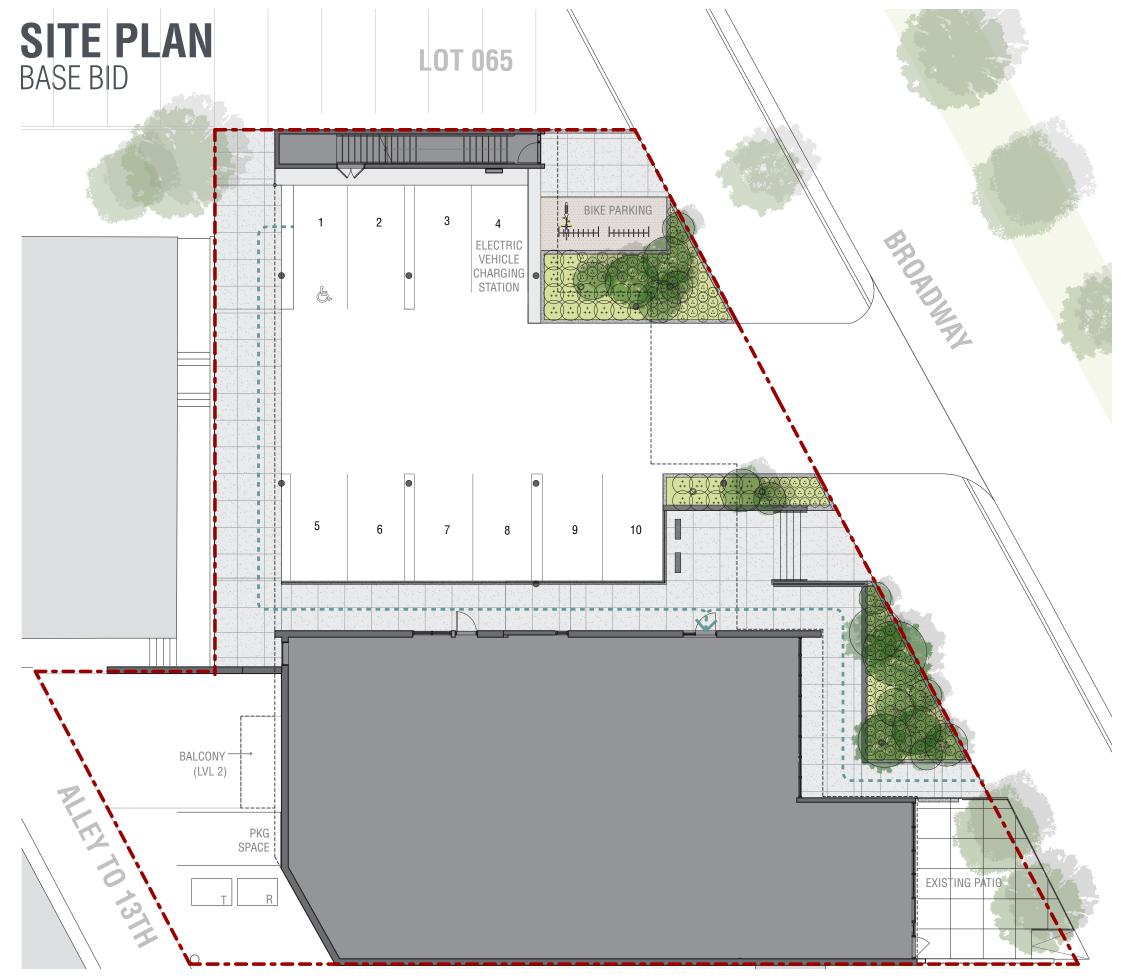
SITE PLAN *

WARP IN DRIVE
LANE TO ABSORB
6" ELEVATION DELTA

4" WIDE DRAINAGE CHANNEL-FOR BOTTOM OF EXISTING STAIRS WEST OF PROPERTY

for reference only - alternates do not affect grading

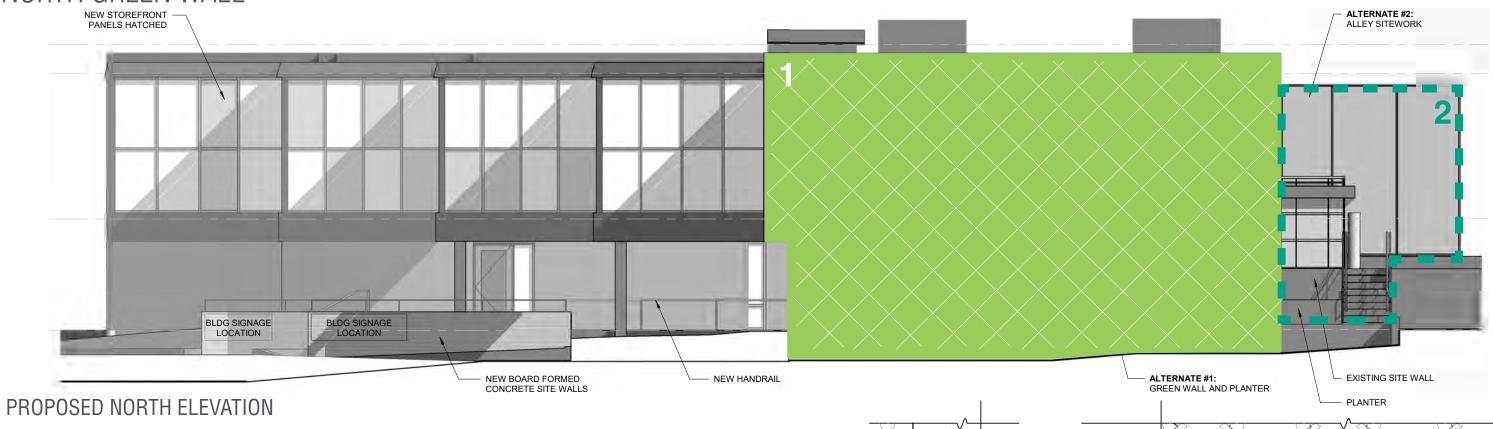
NORTH GREEN WALL

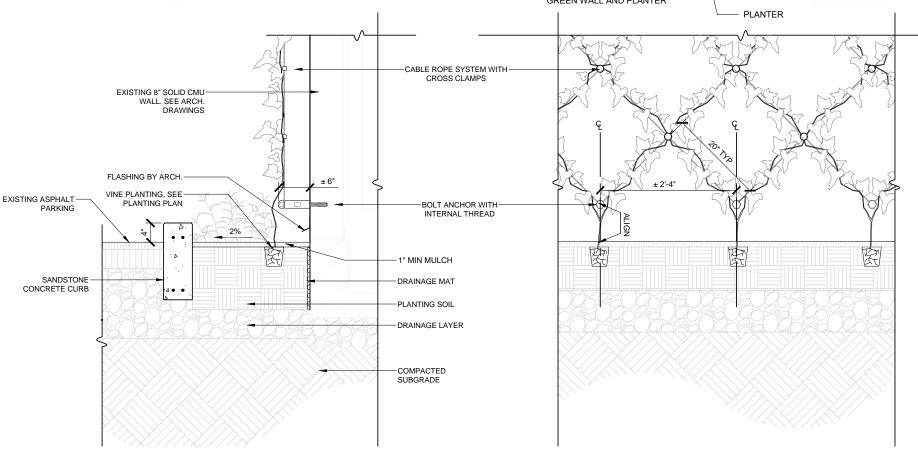
Perforated hollow wall anchor

The perforated anchor is secured with a two-component mortar. The metric internal thread accepts a rope holder.

Bolt anchor with internal thread

Suitable for concrete façades and hard stone. The bolt anchor expands and grips when the threaded rod is screwed in.

> STEEL CABLE TRELLIS ANCHOR DETAIL OPTIONS

SECTION + ELEVATION

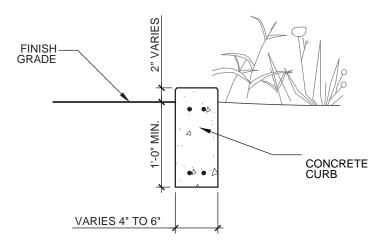
CONCRETE CURB

- NOTE:
 1. FOR FLUSH CONDITIONS ELIMINATE 2" REVEAL
- 2. EXPANSION JOINTS SPACES MAX 20'-0" CENTER TO CENTER.

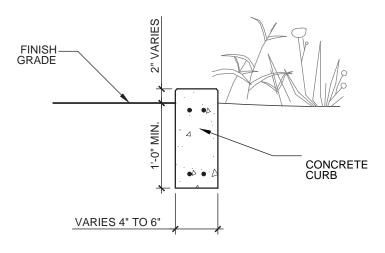
CONCRETE CURB

- 1. FOR FLUSH CONDITIONS ELIMINATE 2" REVEAL
- 2. EXPANSION JOINTS SPACES MAX 20'-0" CENTER TO CENTER.

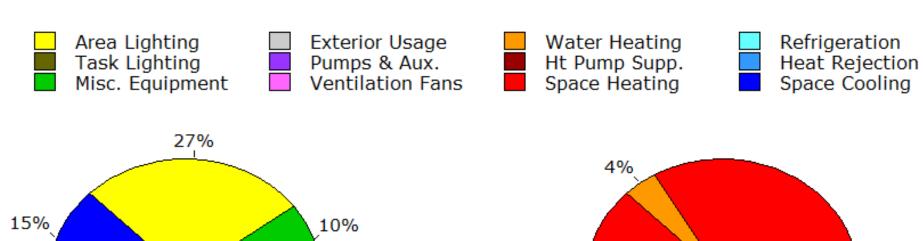
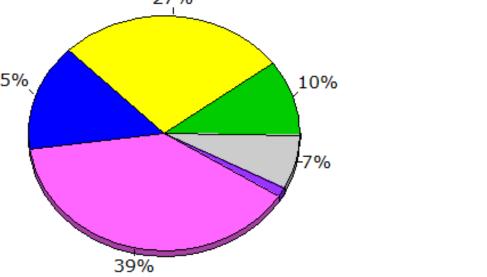
Annual Energy Consumption by Enduse

Electricity kWh (x000)	Natural Gas MBtu	Steam Btu	Chilled Water Btu
Space Cool	17.46	-	-	-
Heat Reject.	-	-	-	-
Refrigeration	-	-	-	-
Space Heat	-	447.47	-	-
HP Supp.	-	-	-	-
Hot Water	-	19.95	-	-
Vent. Fans	45.86	-	-	-
Pumps & Aux.	1.57	-	-	-
Ext. Usage	8.76	-	-	-
Misc. Equip.	12.31	-	-	-
Task Lights	-	-	-	-
Area Lights	32.48	-	-	-
Total	118.43	467.42	-	-

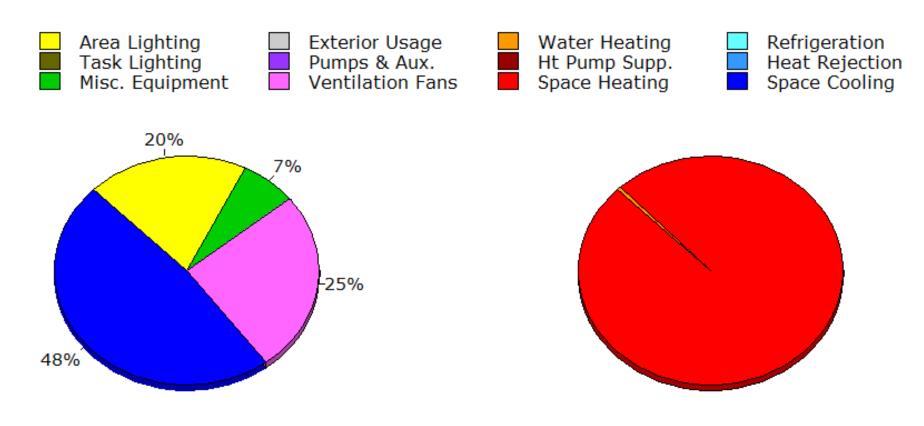
Annual Peak Demand by Enduse

Electricity kW	Natural Gas Btu/h (x000)	Steam Btu/h	Chilled Water Btu/h
Space Cool	23.62	-	-	-
Heat Reject.	-	-	-	-
Refrigeration	-	-	-	-
Space Heat	-	806.77	-	-
HP Supp.	-	-	-	-
Hot Water	-	4.28	-	-
Vent. Fans	12.62	-	-	-
Pumps & Aux.	-	-	-	-
Ext. Usage	-	-	-	-
Misc. Equip.	3.41	-	-	-
Task Lights	-	-	-	-
Area Lights	9.87	-	-	-
Total	49.51	811.05	-	-

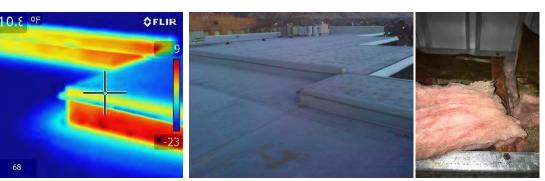
Heat loss is indicated by the red color. Insulation has been compromised over the years.

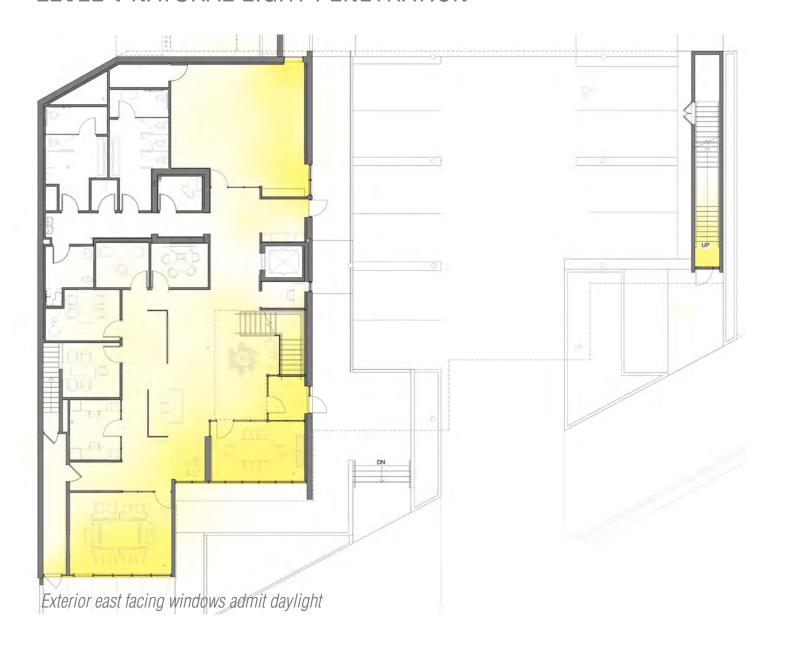
LEVEL 1 NATURAL LIGHT PENETRATION

- FILM APPLIED TO STOREFRONT GLAZING TO REDUCE GLARE AND SOLAR HEAT GAIN WHILE ADMITTING NATURAL LIGHT
- WEST FACING WINDOWS ENLARGED TO ADMIT MORE NATURAL LIGHT
- GLASS DOOR TO WEST FROM NOURISH SPACE TO ADMIT DAYLIGHT
